First Annual Monitoring Report

Oak Woodland Habitat Revegetation/Mitigation Program for the Santa Anita Dam Riser Modification and Reservoir Sediment Removal Project

**California Department of Fish and Wildlife
Streambed Alteration Agreement
No. 1600-2008-0173-R5**

October 2016
Revised February 2017

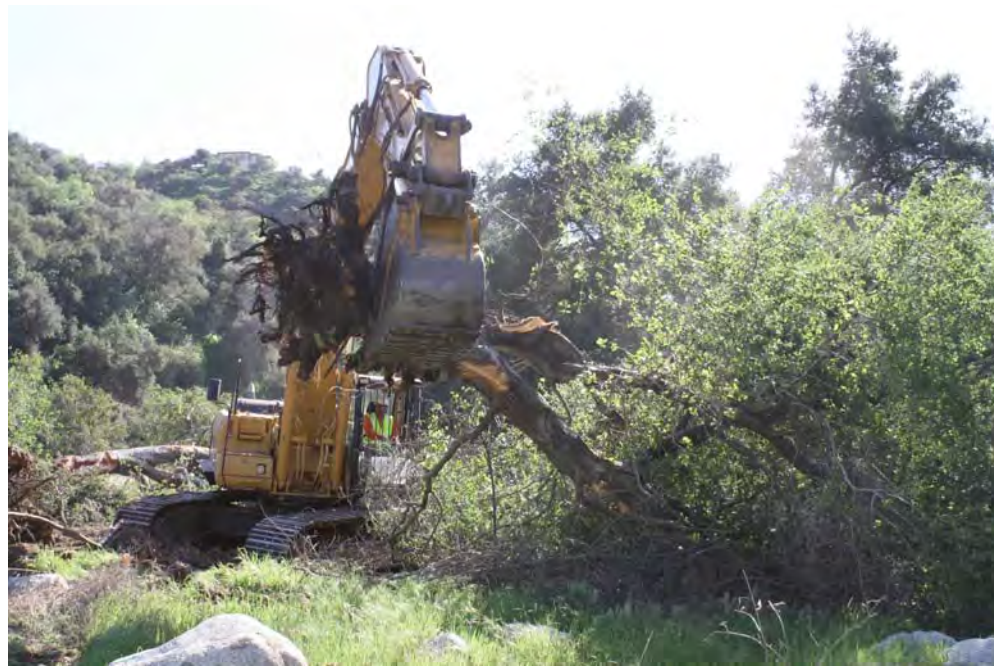
January 2011. Native tree trunks, brush piles, and leaf litter, were carefully salvaged by the County of Los Angeles Department of Public Works (LACDPW) during vegetation clearing activities associated with the sediment removal project.

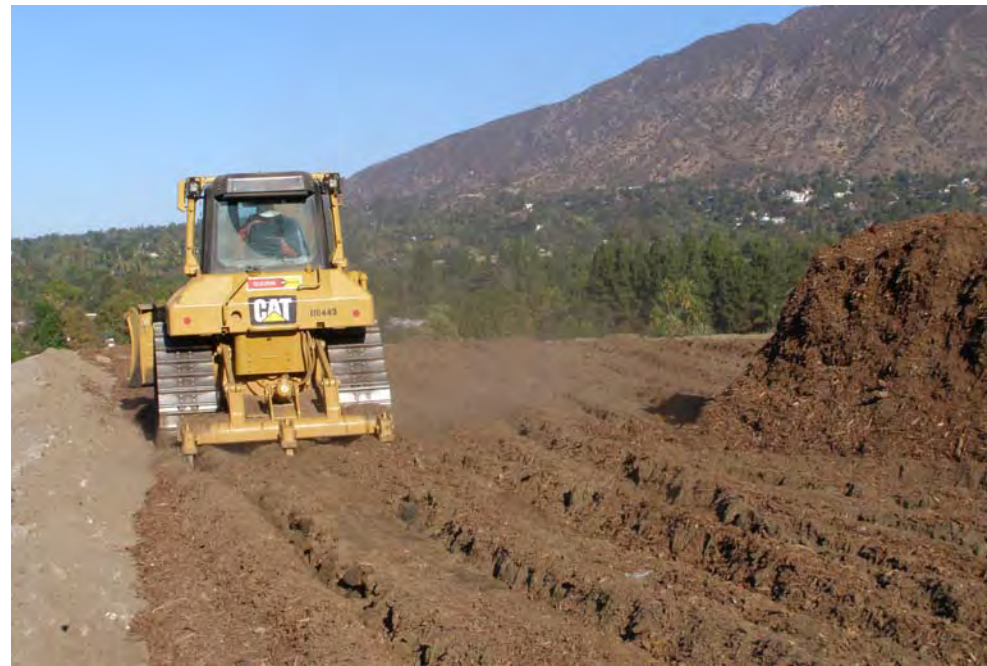
September 2013. The Restoration Contractor (Nakae & Associates, Inc.) performed soils preparation, including the incorporation of mulched native vegetation into the oak woodland mitigation site via machine ripping.

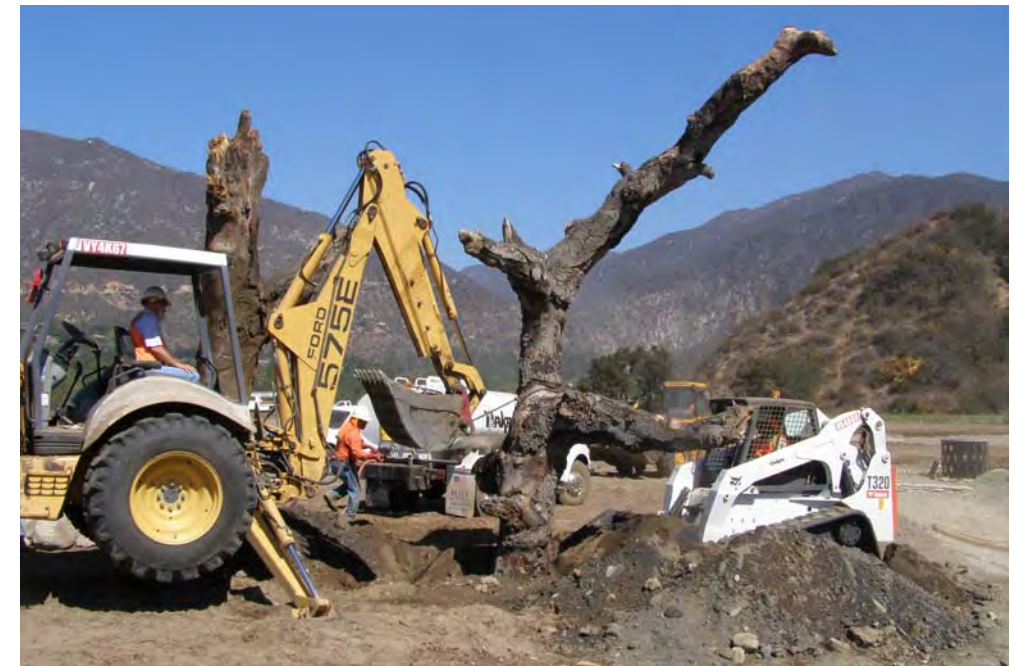
September 2013. Installation and re-compaction of natural oak snags on the mitigation site.

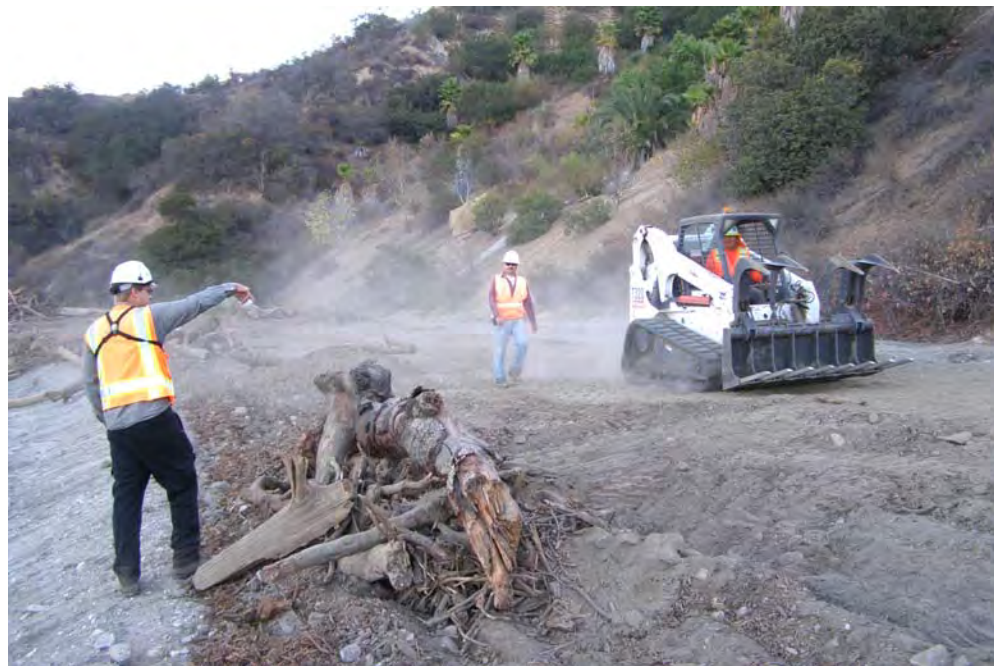
September 2013. The Restoration Ecologist (BonTerra Psomas) coordinated the placement of coarse woody debris with the Restoration Contractor.

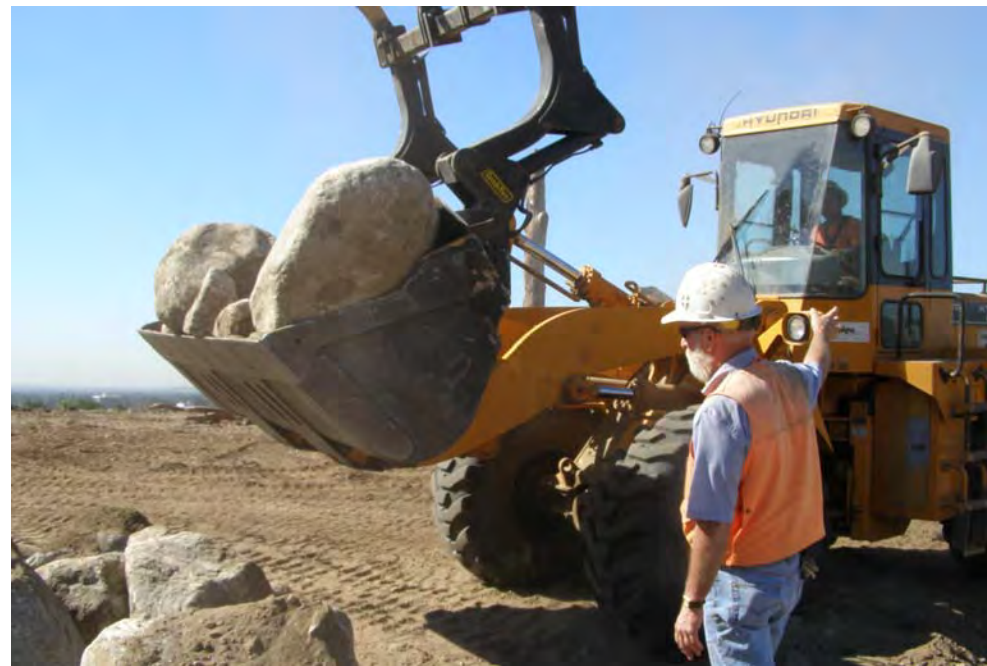
September 2013. The Restoration Contractor placed salvaged rock in numerous assemblages in coordination with the Restoration Ecologist. Only large boulders were used for this purpose, in order to create sizeable internal/interstitial gaps for wildlife shelter.

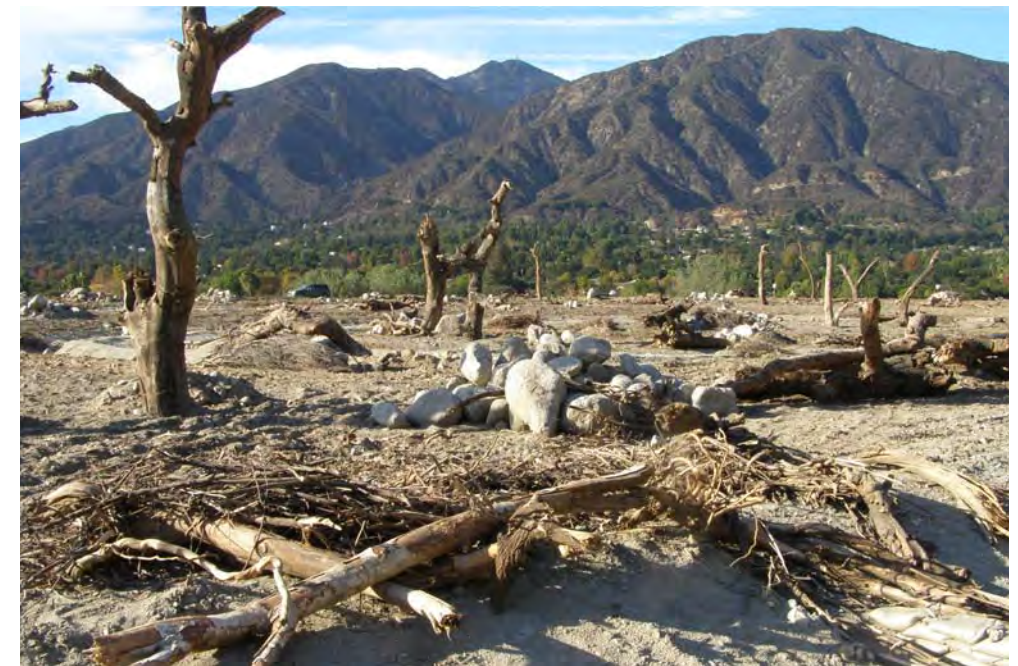
November 2013. A naturalistic array of placed snags and a scatter of boulders and coarse woody debris. Many tons of these materials were placed on the site.

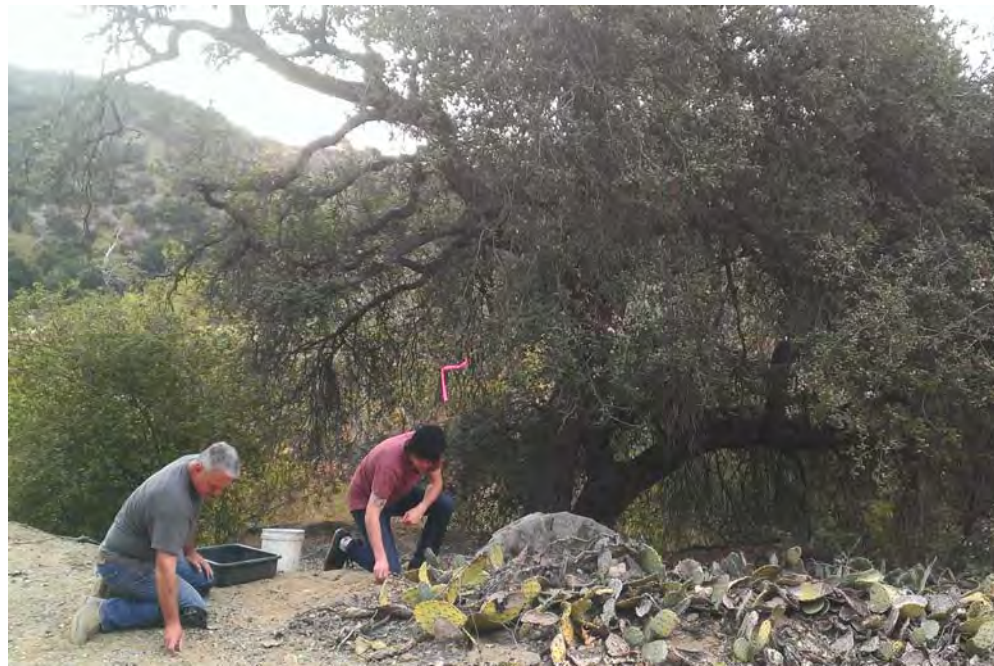
October 2013. S&S Seeds/Noll Seed Company collecting acorns of coast live oak along Santa Anita Wash. Acorns were collected from a minimum of 50 oak trees on the site, to adequately sample the genetic diversity of the oak population.

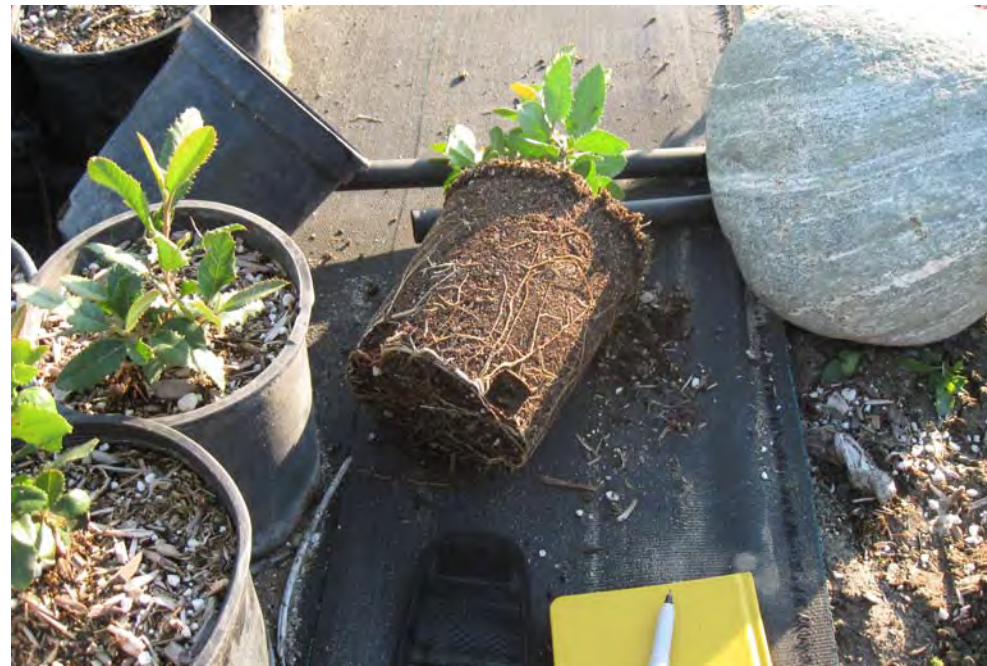
January 2014. The Restoration Ecologist (BonTerra Psomas) performed ongoing inspections of contract-grown container materials at the nurseries, including the 'de-potting' of several specimens to assess root development.

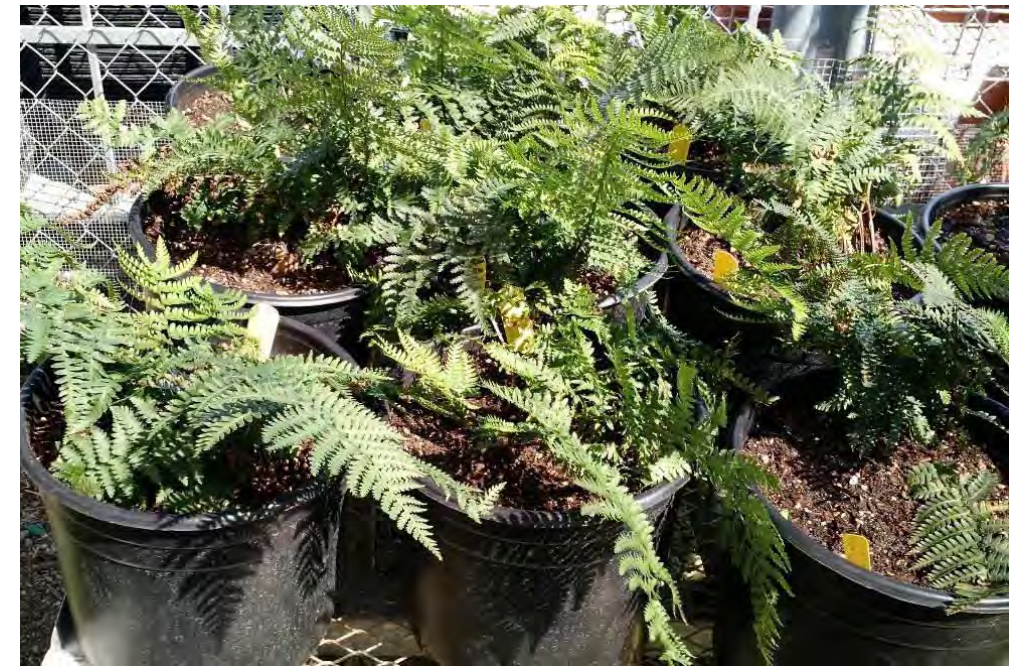
January 2014. Rancho Santa Ana Botanic Garden collected acorns of rare oaks, and rhizomes (roots) of several native fern species, for propagation as container plants (e.g., these 5-gallon 'stock plants' of coastal woodfern).

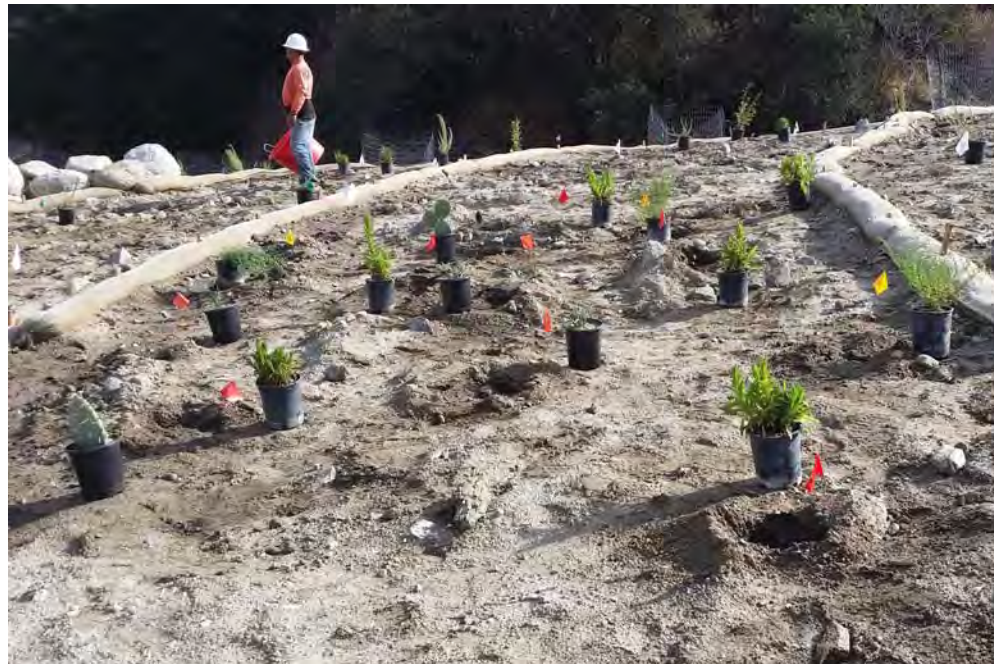
January 2014. The Restoration Contractor installed contract-grown container plants in naturalistic layouts flagged by the Restoration Ecologist.

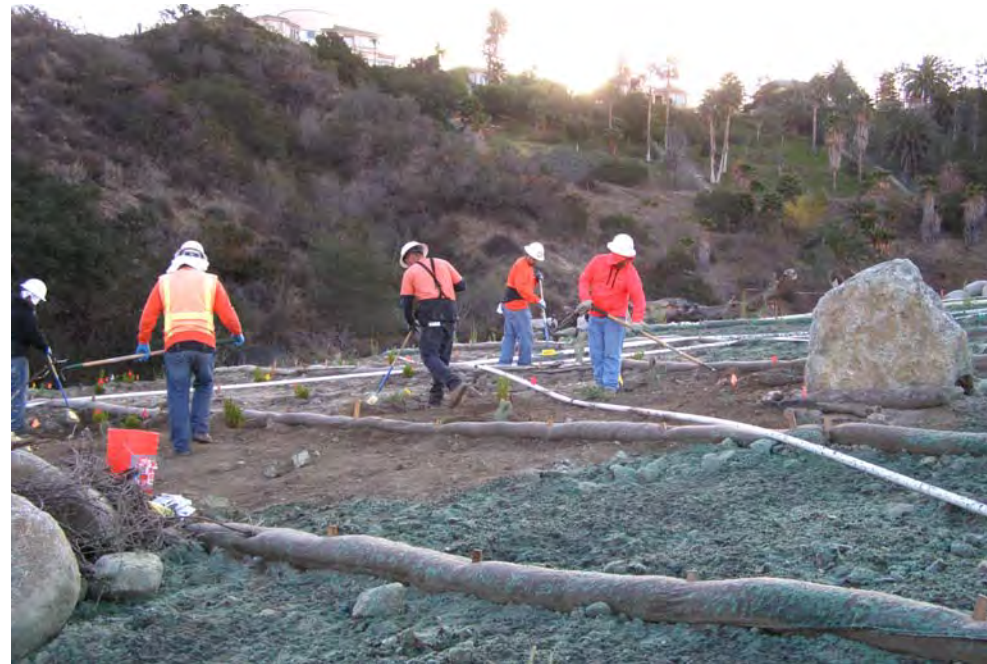
February 2014. After the completion of hydroseeding (green area, foreground), hand seeding of herbaceous species was performed in select patches that were planted only with native succulents (cactus and yucca) and containerized native herbs.

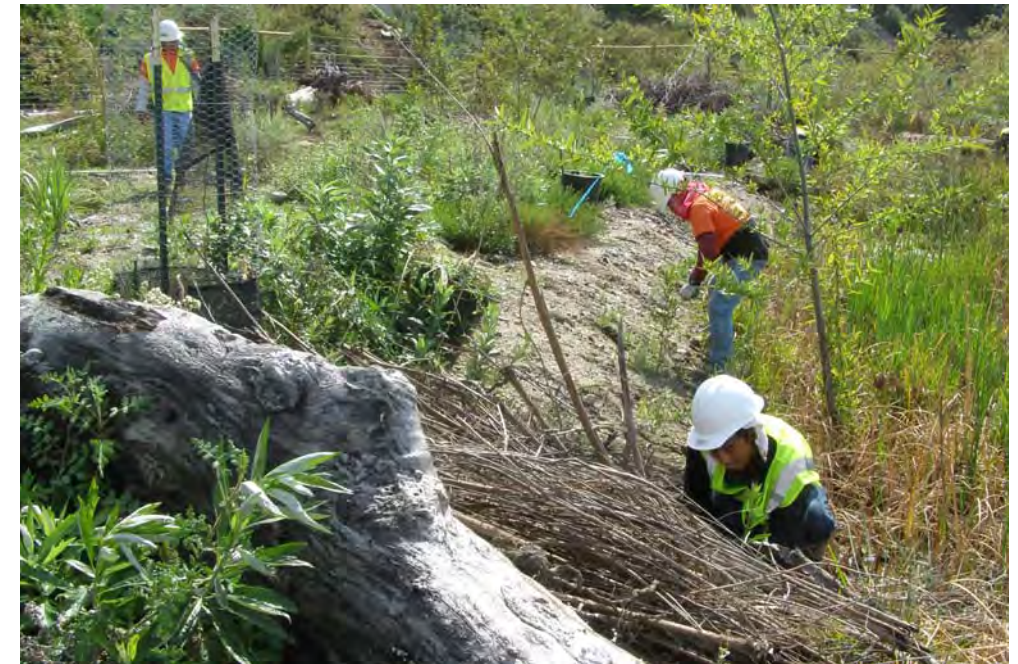
March 2015. The Restoration Contractor performs ongoing maintenance to avoid the proliferation of weed species while protecting sensitive biological resources.

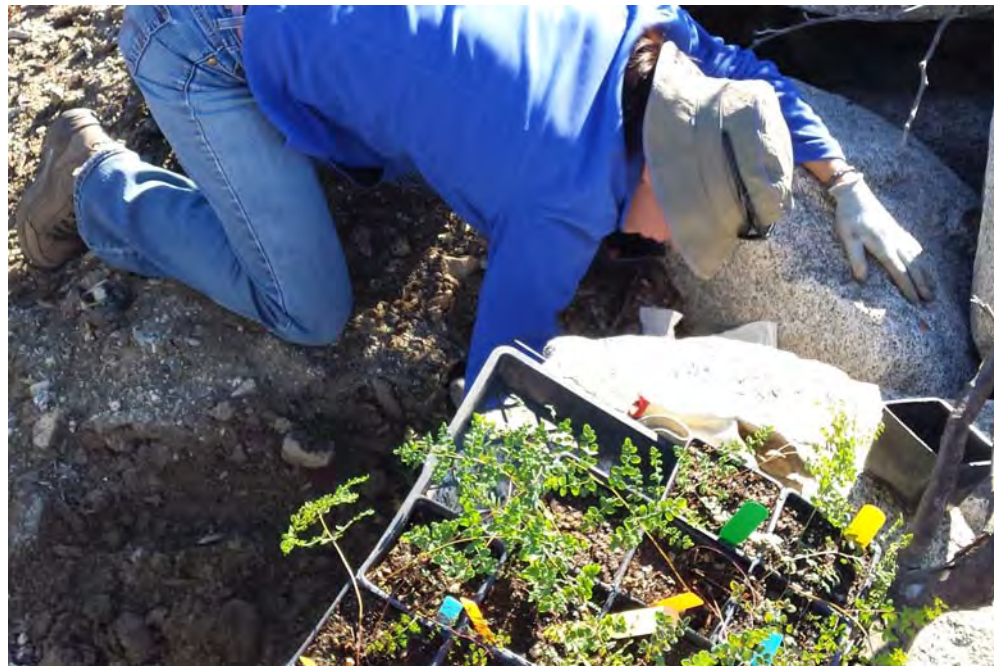
December 2015. BonTerra Psomas' Restoration Ecologist identifying suitable niche planting sites for native ferns (foreground: a nursery flat of coffee cliff-brake) among a placed boulder assemblage. Rhizomes of several native fern species were collected in the local sub-watershed and propagated as container plants by Rancho Santa Ana Botanic Garden (RSABG).

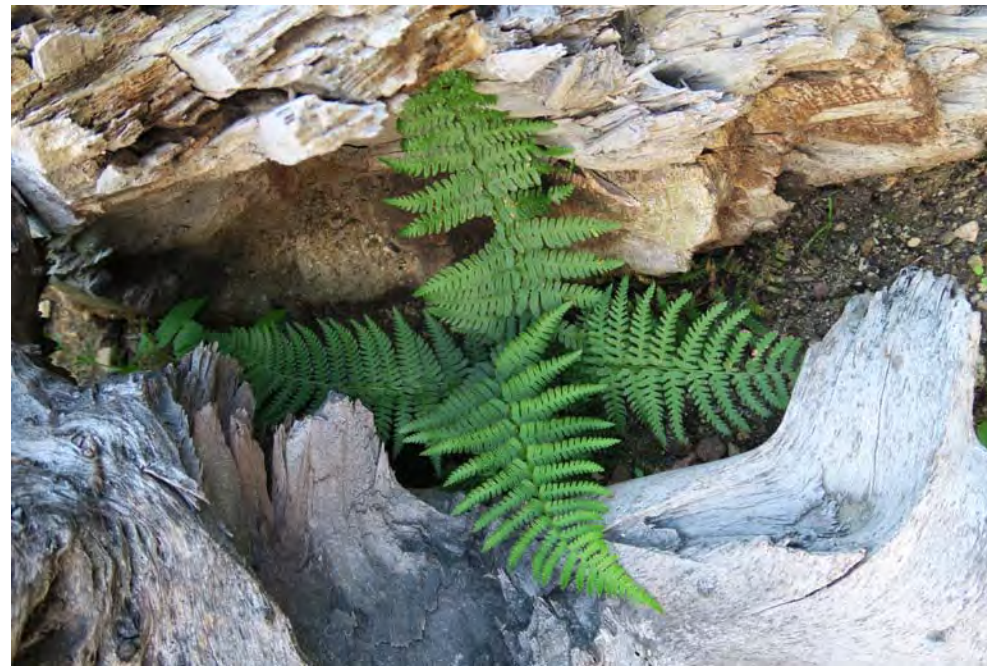
March 2016. Planted coastal woodfern propagated by RSABG from rhizomes collected in the local subwatershed. A total of five native fern species, and native bush spike moss, have become established on the formerly barren mitigation site. These plant species do not occur on typical habitat restoration sites in Southern California.

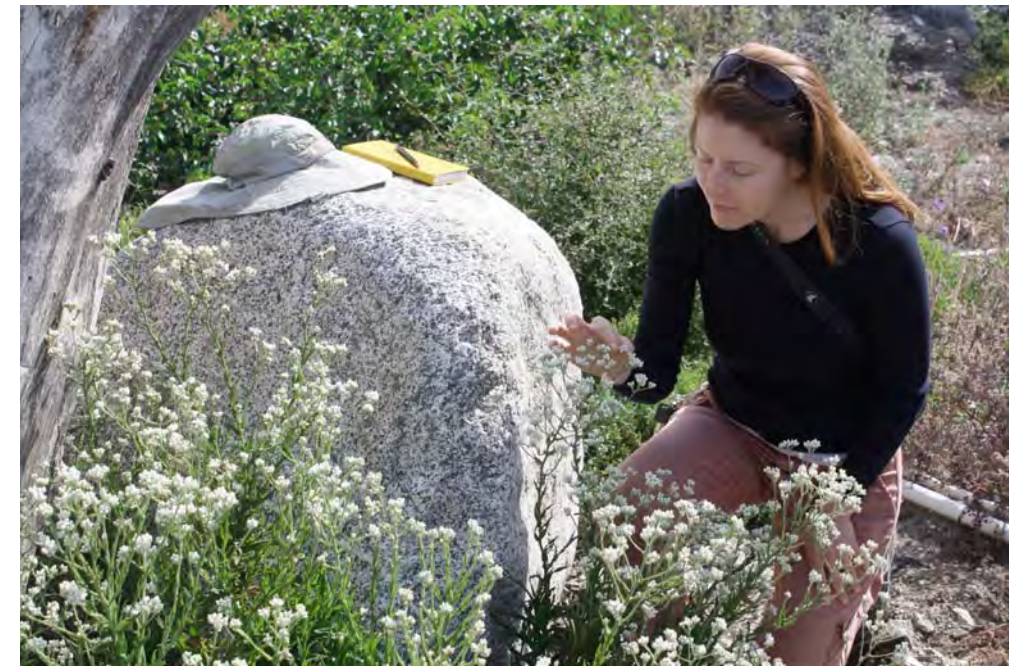
March 2015. The Restoration Ecologist performs ongoing assessments of vegetative cover and diversity on the site and catalogs the wide variety of native arthropods/insects that are colonizing the planting area.

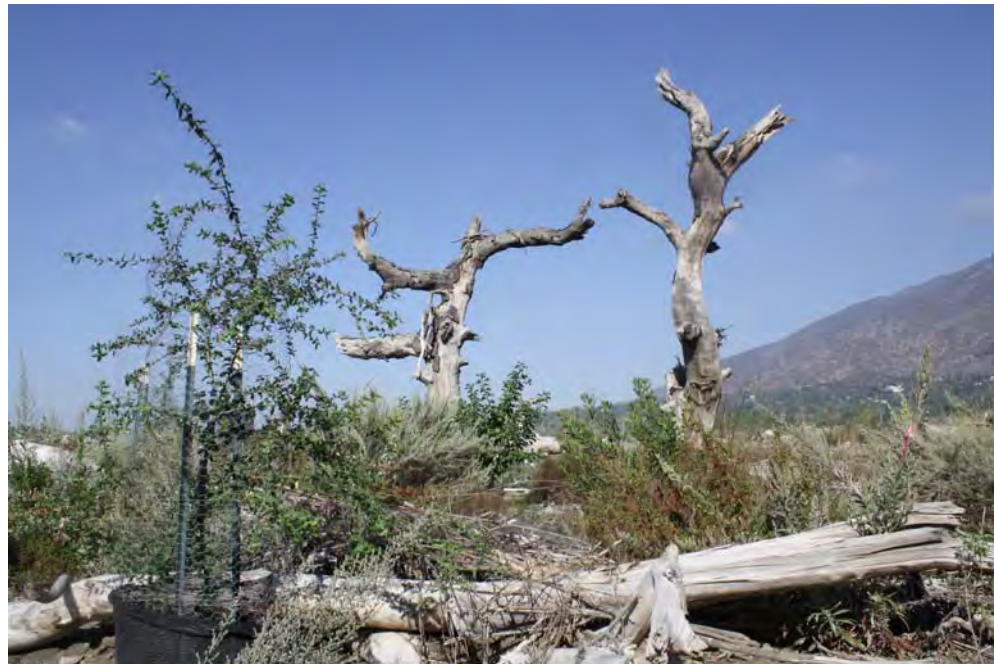
September 2015. Robust growth of a planted coast live oak tree amid placed coarse woody debris and a diverse understory of native shrubs and herbaceous plants. Two large, placed natural snags are in the background.

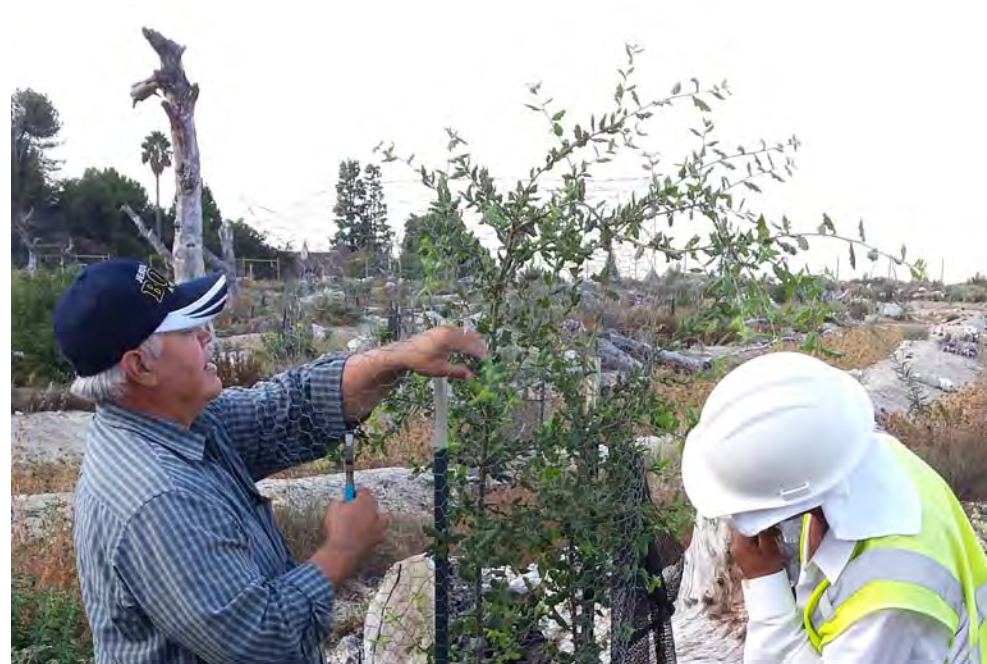
September 2015. The Restoration Contractor is carefully removing the caging from coast live oak saplings that have grown above deer-browsing height.

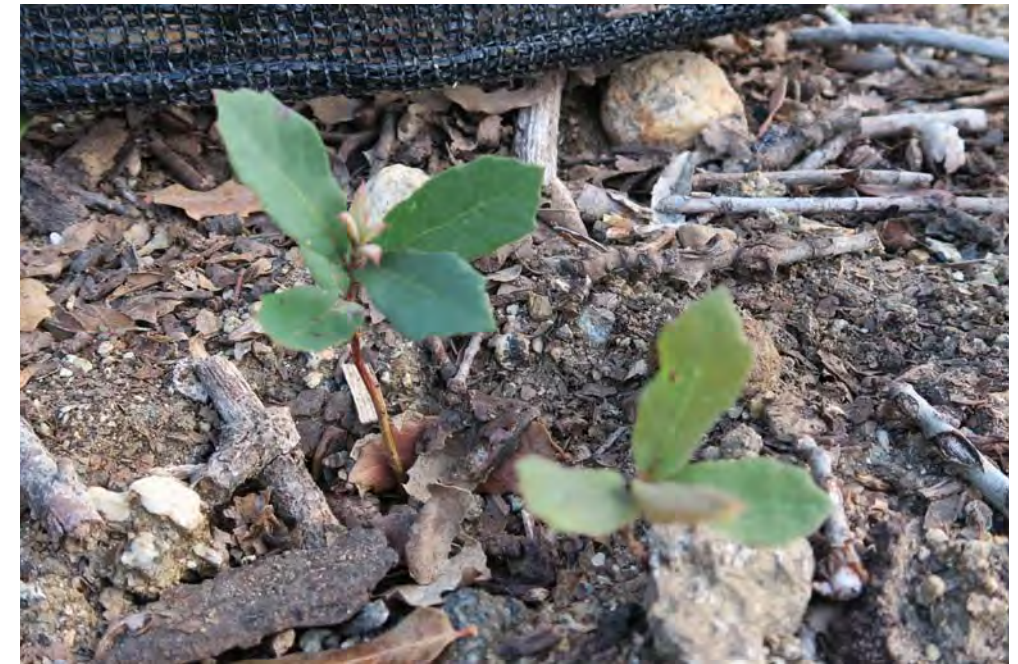
March 2016. Recently germinated seedlings of Engelmann oak that were collected in the local subwatershed and planted on the oak woodland mitigation site in fall 2015. Supplemental seeding of local oak species will occur each year for the first five years of the long-term maintenance and monitoring program.

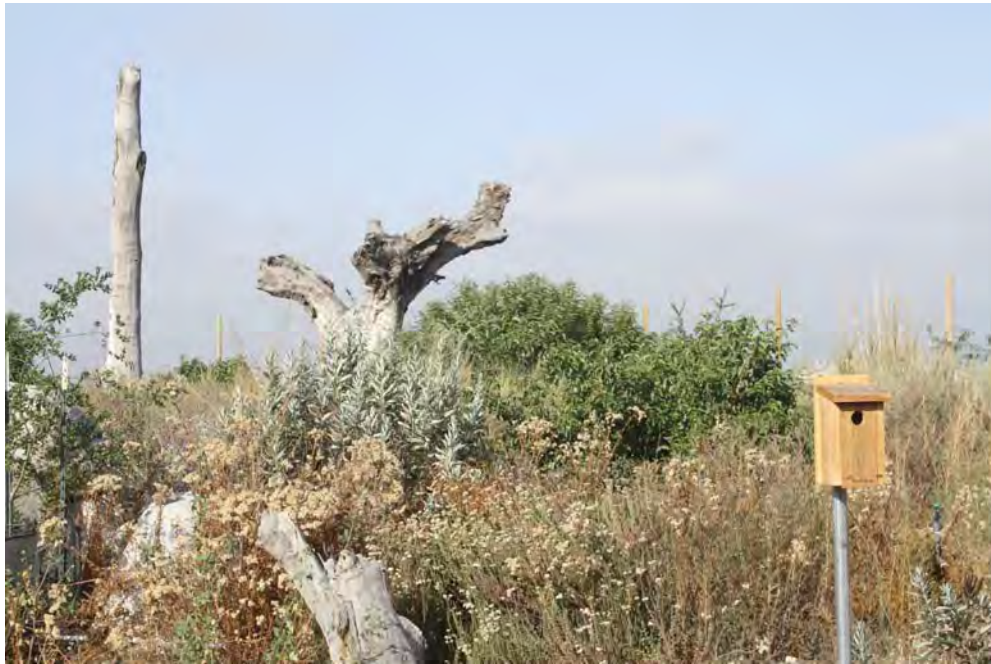
July 2016. Planted coast live oak (far left), western bluebird nest box (right), and placed oak/sycamore snags (background), amid diverse planted/seeded herbs (e.g., mugwort, California everlasting) and shrubs (e.g., little graceful golden currant, California buckwheat).

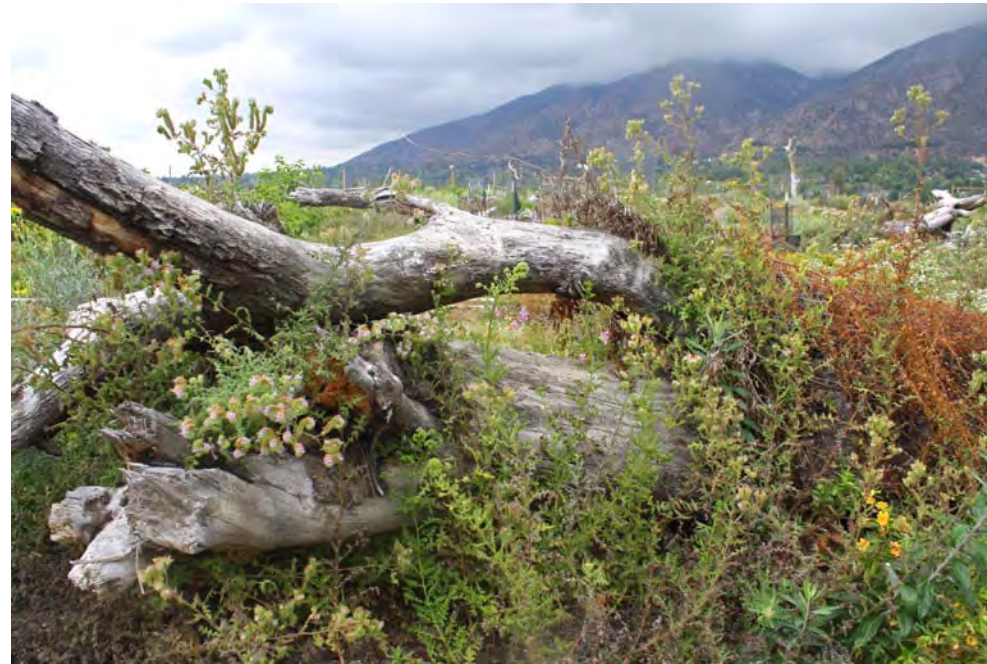
May 2015. The coarse woody debris (CWD) and clambering native herbs (e.g., branching phacelia, coast morning-glory) offer a sense of an ancient landscape on the recently installed habitat area.

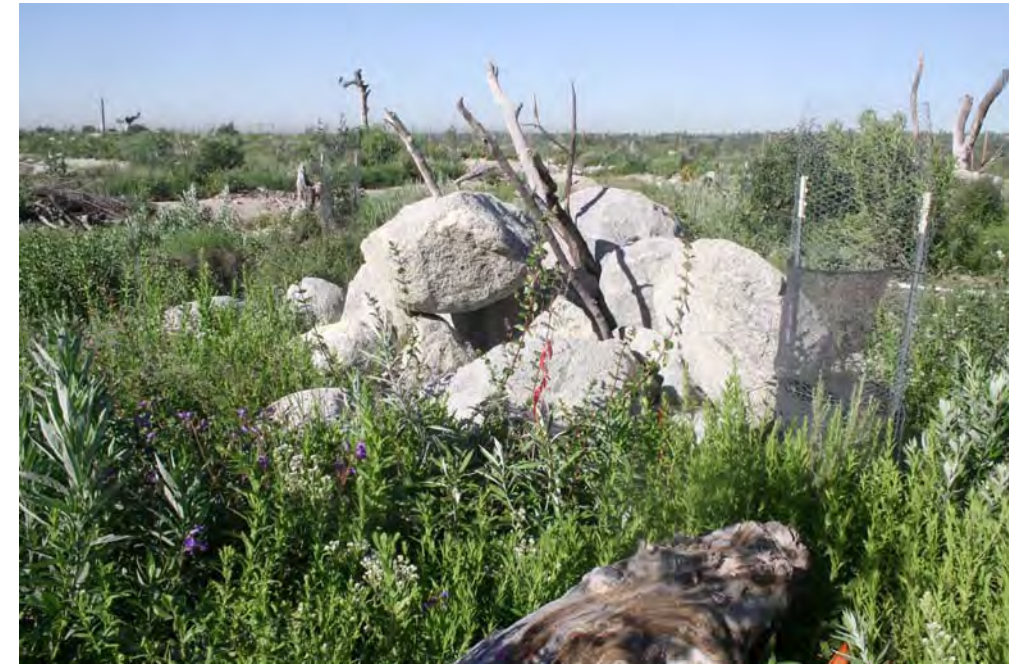
May 2016. A boulder assemblage with placed branches to provide perches for birds. The naturalistic outcrops were designed to retain emergent (uncovered) rock surfaces as the surrounding vegetation grows to maturity. A red-tailed hawk is perched on a placed natural snag in the background.

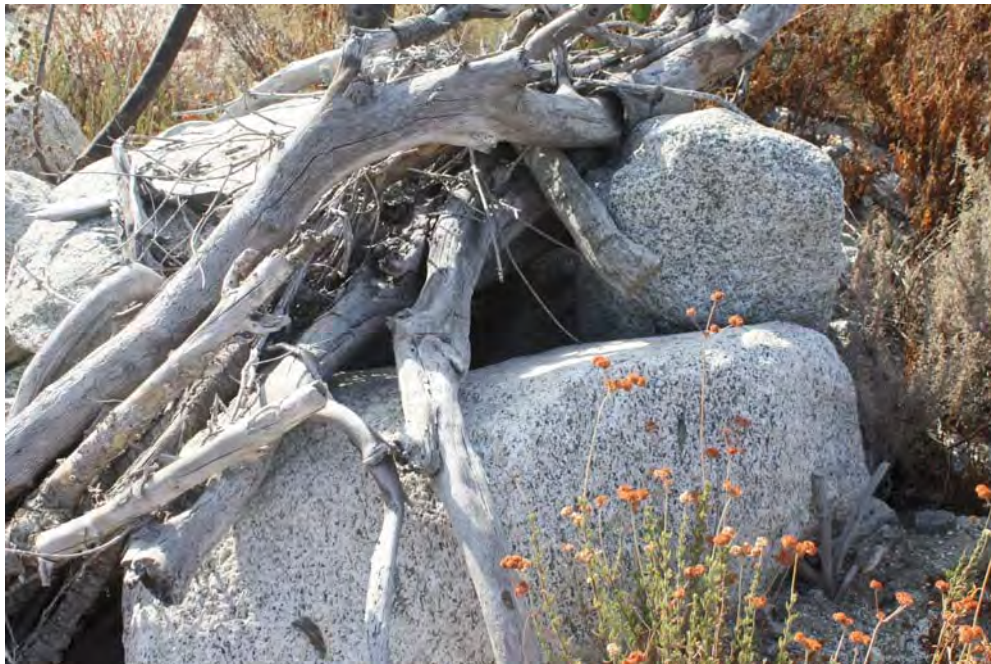
July 2016. The boulder and CWD assemblages were configured to provide both internal shelter and points of entry for wildlife species. Several of these features are already inhabited by California ground squirrels, and a variety of reptiles are regularly observed on the site (e.g., striped racer—a native snake species).

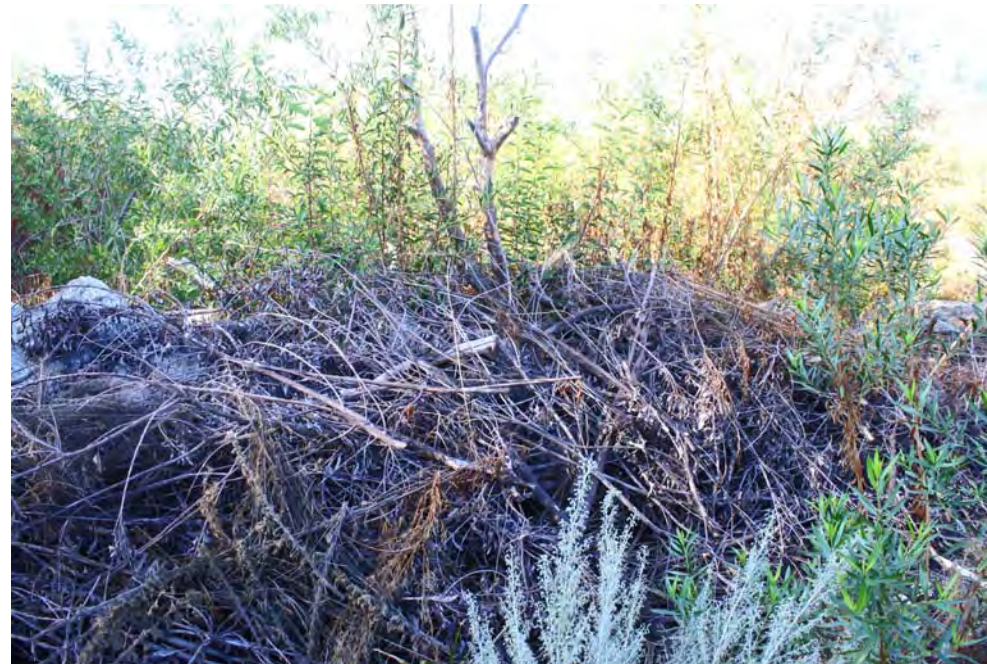
October 2015. Placed piles of salvaged native brush provide valuable cover for wildlife and improve moisture retention/percolation.

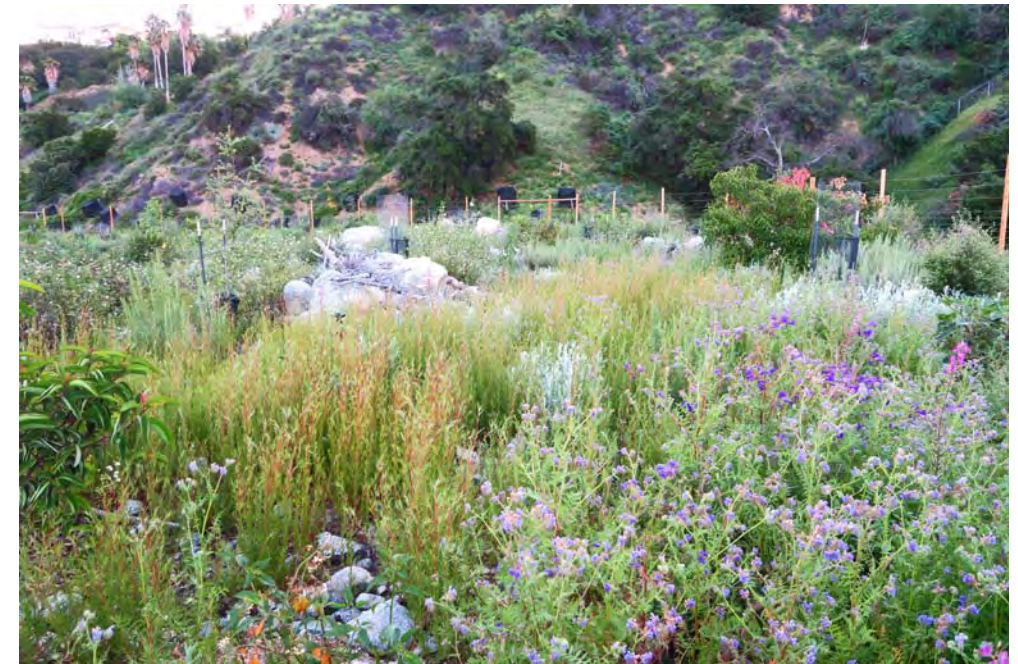
May 2016. A seeded meadow was established between the debris assemblages and planted oaks on the oak woodland site. The native herbaceous species shown here include purple clarkia, hairy everlasting, wild heliotrope phacelia, stinging lupine, white nightshade, wild Canterbury bells, and Wright's jimsonweed.

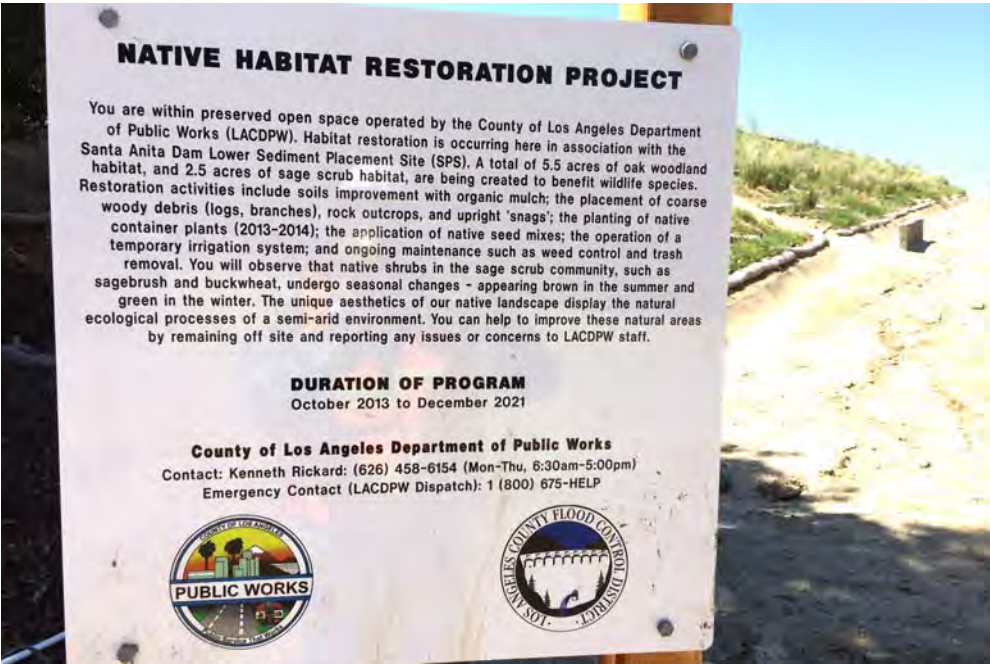
September 2014. The Restoration Contractor (Nakae & Associates, Inc.) installed interpretive signage at several locations around the mitigation site, using information prepared by the Restoration Ecologist (BonTerra Psomas) and approved by the County of Los Angeles Department of Public Works (LACDPW).

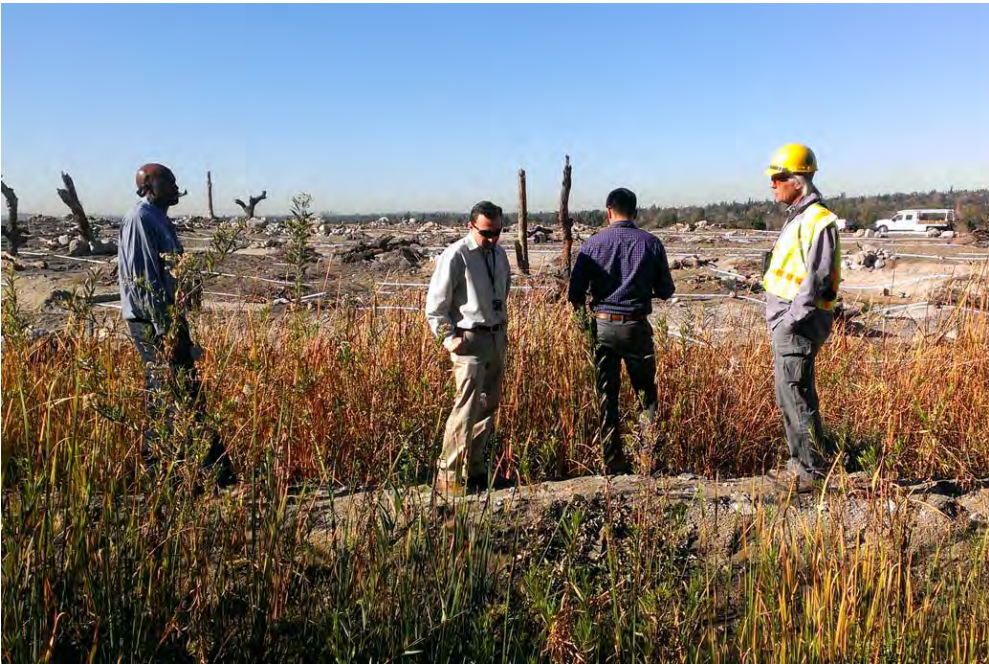
January 2014. The LACDPW and the Restoration Ecologist coordinate with the San Gabriel Valley Vector Control District (SGVVCD) on their mosquito inspections and treatments. The SGVVCD uses ecologically friendly materials/methods to minimize adverse impacts on beneficial aquatic insects to enhance the complex food web on the habitat site.

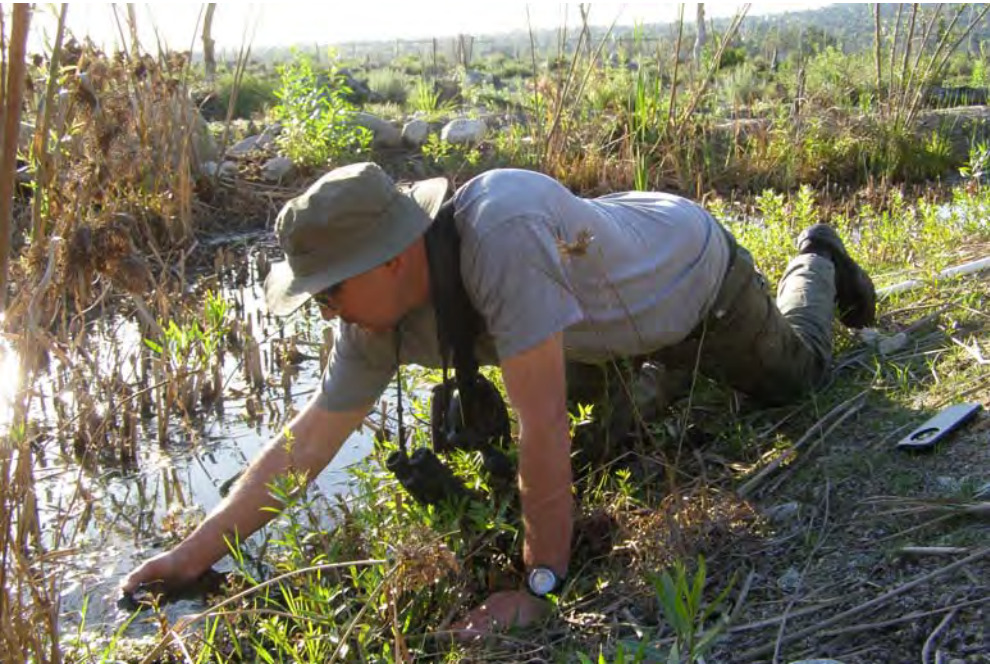
March 2015. The Restoration Ecologist monitors the breeding cycle of native Baja California treefrogs on the habitat creation site.

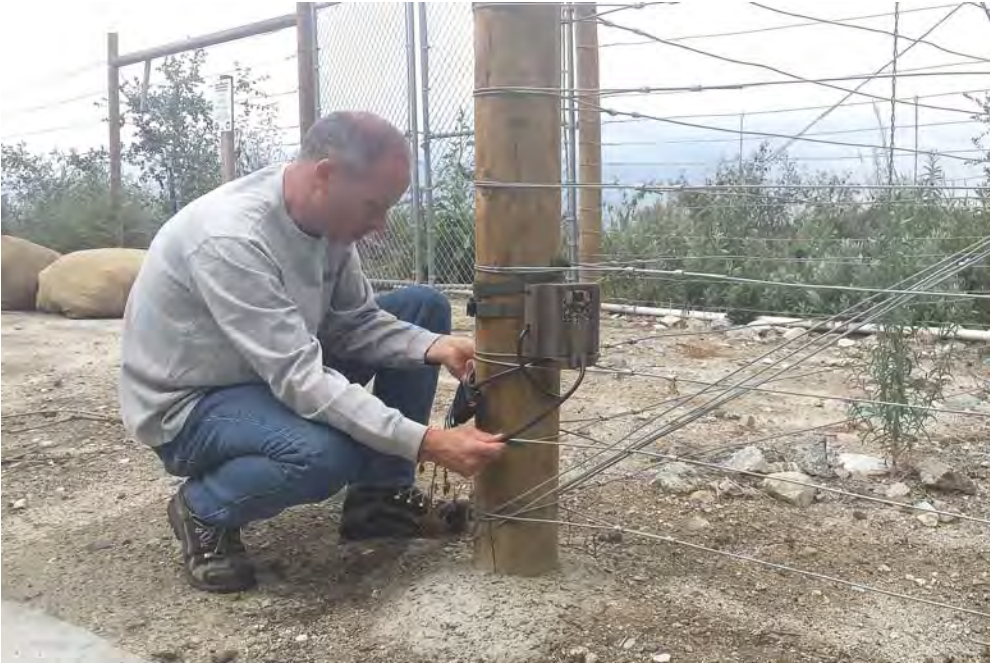
May 2016. BonTerra Psomas installed a motion-activated 'camera trap' to assess round-the-clock wildlife activities on the site. The temporary, wildlife-friendly enclosure fence (visible in photo) is eight feet high, and is constructed of smooth wire only (no barbed wire).

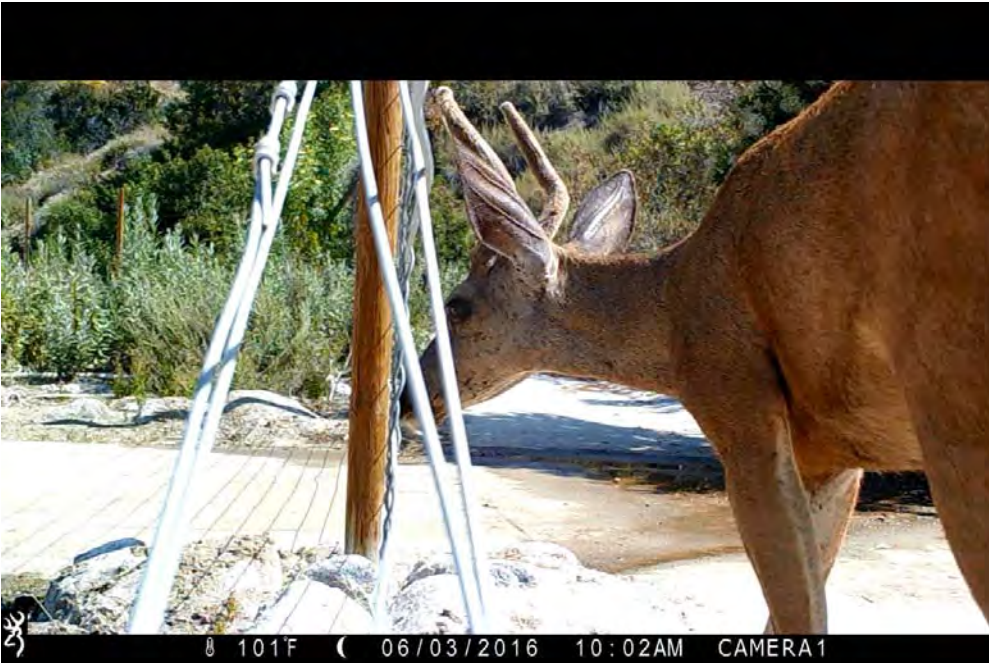
June 2016. Mule deer have been observed (directly, and via camera) testing the eight-foot-high wildlife fence. Deer have also been observed moving locally around the enclosure fence, which was off-set from the adjacent toe-of-slope for this reason.

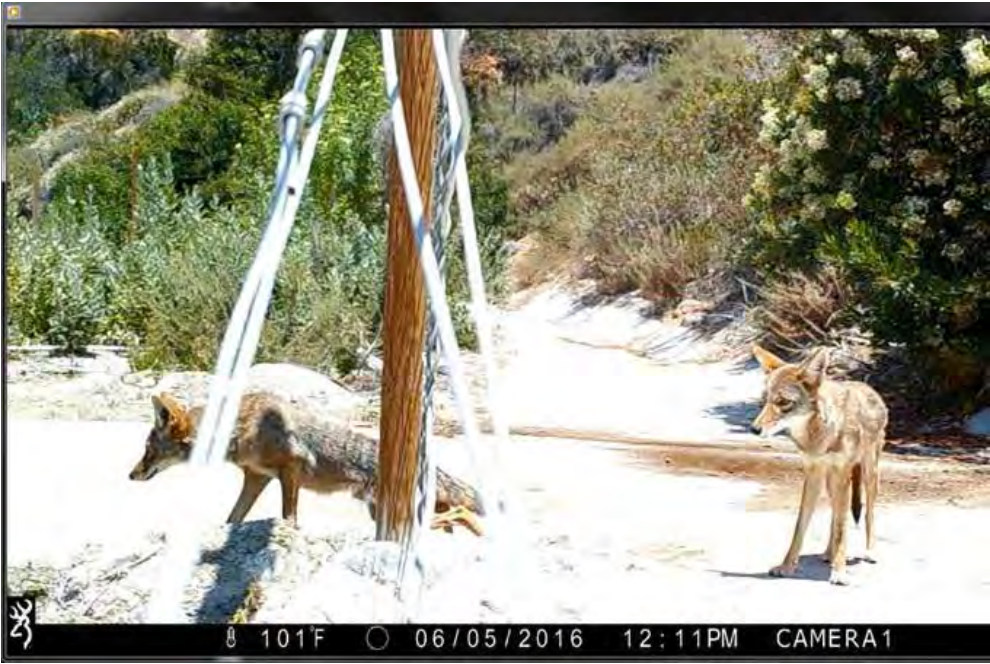
June 2016. Coyotes were captured on video readily moving through the enclosure fence, as intended per design. The fencing is meant to exclude only larger mammals (bears and deer) until the planted oaks are large enough to withstand herbivory, and the vegetation is sufficiently mature to resist trampling damage.

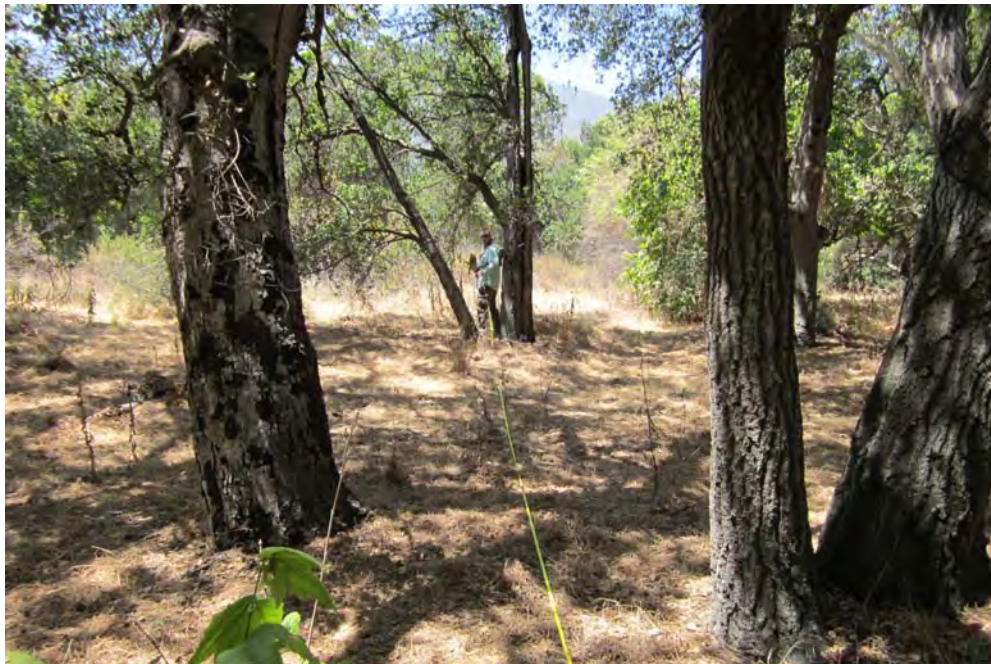
July 2013. Oak woodland reference site (Middle Sediment Placement Site [SPS]). Although the reference site contains numerous mature coast live oak and western sycamore trees, the understory vegetation is predominantly weedy (e.g., ripgut brome [grass]).
